November 4, 2010

RE: Site Visit and Recommendations
Smokey Mountain Smelters
Knoxville, Tennessee
Terracon Project: E2105082

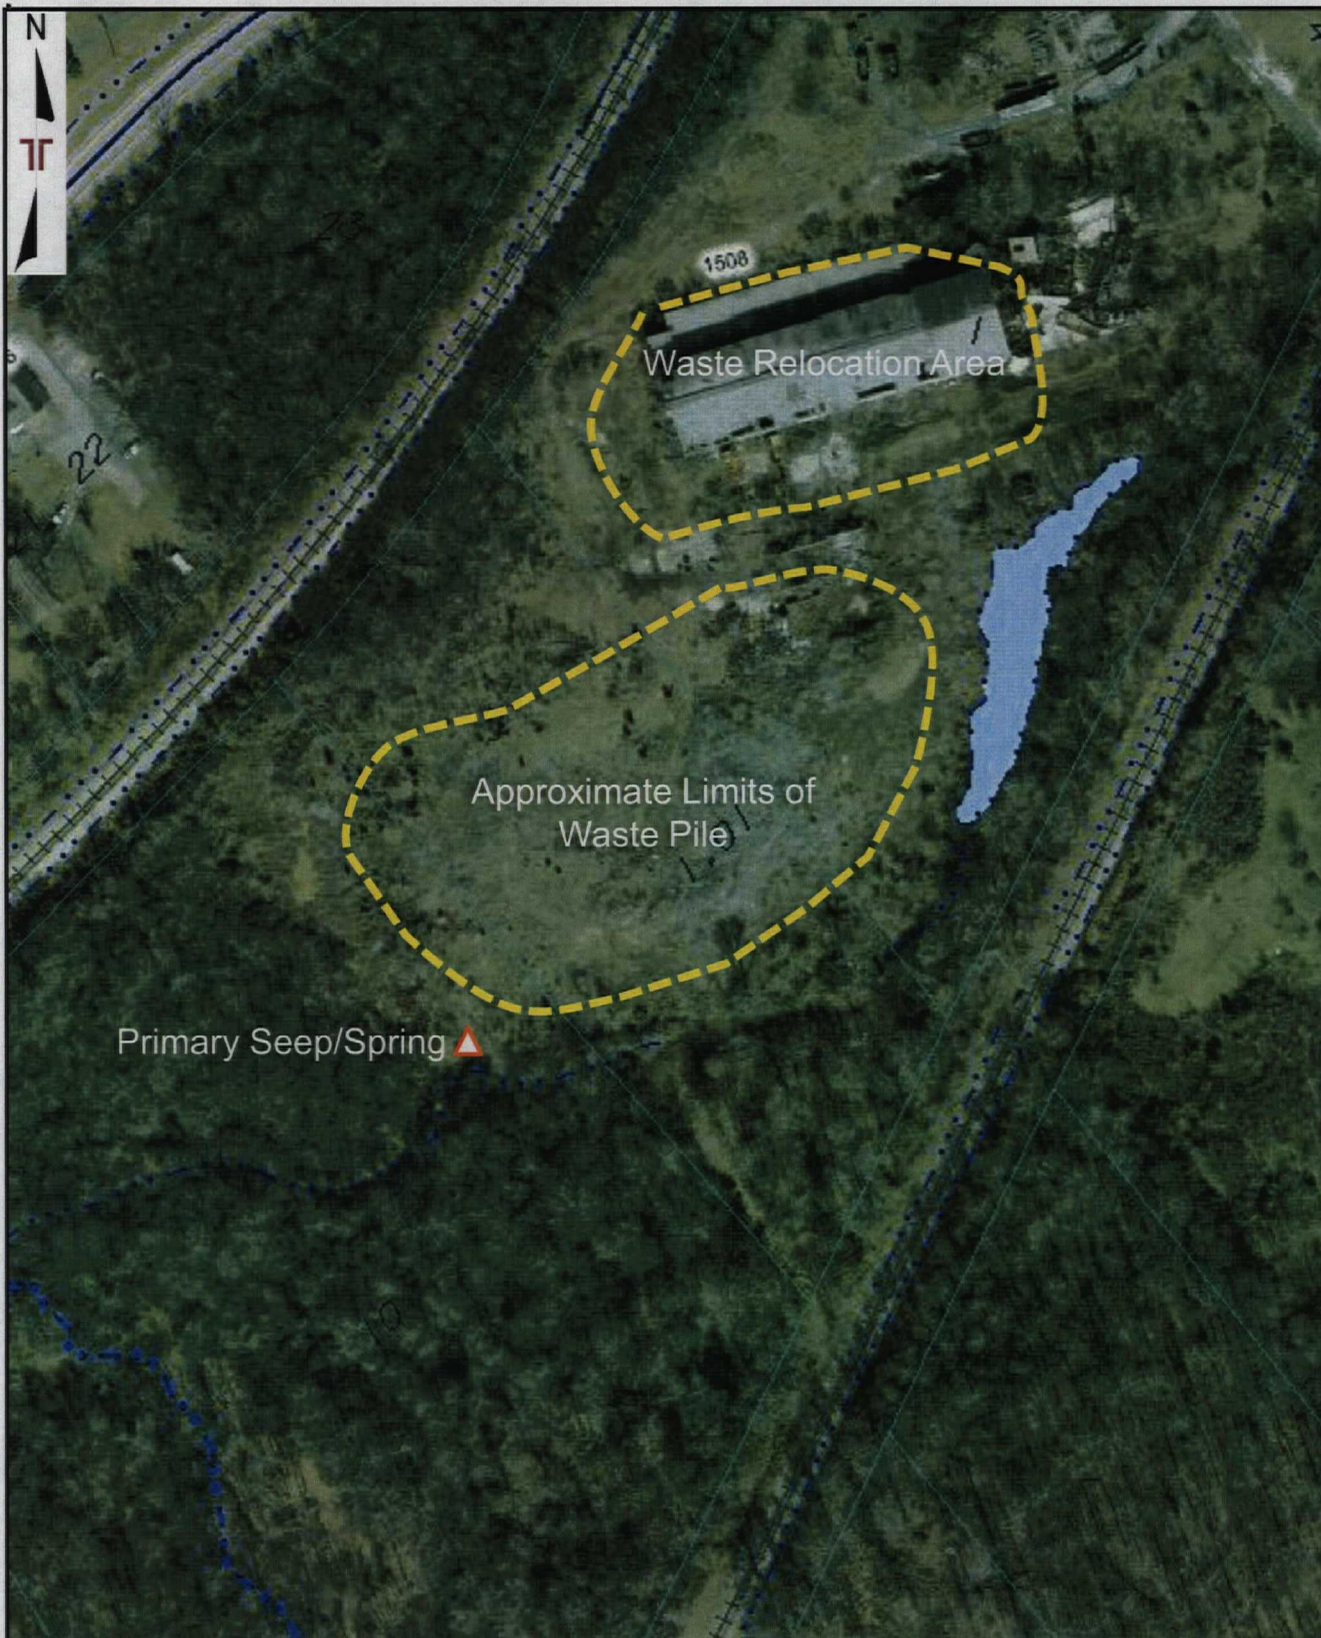
Two types of leachate seeps were observed. A primary seep exists at the toe of the waste pile along the southern edge of the waste pile. This seep appears to be the lowest elevation of the waste pile and was likely the lowest natural elevation of the waste area prior to waste placement. This primary seep could be spring fed from higher elevations or could be where the natural native clay soils have created a bottom barrier to infiltration causing the preferential flow path of leachate to be along the surface of the old natural ground surface until discharge at the ground surface at the lowest elevation. Several water impoundments are located upgradient of this seep location. No surface discharge outlet was observed for these impoundments. Thus, the primary outlet of the impounded water would be seepage into soils and/or the waste mass and discharge at this spring/seep location. Stormwater infiltration into the waste pile would also be a source for leachate discharge at this location. Improving the drainage features at the site and permanently draining these impoundments in addition to grading the waste pile

Secondary seeps were observed at several locations along the edges of the waste pile. These seeps appeared to be a milky white discharge of small quantity. Reducing the infiltration of rain water into the waste pile may significantly reduce the presence of these seeps. Figure 1 illustrates the observed location of these seeps.

for positive drainage and placing an infiltration barrier over the waste would likely significantly reduce the amount of leachate seepage from this location.
